Rescue mission for an Austin-Healey that appeared to be out for the count

When the Austin-Healey 100-6 BN4 was involved in a crash, its owner was deeply distressed. The damage was considerable — but it didn't signal the end of the road. A bodyshop based in Düsseldorf took on the legendary roadster, rebuilt it and gave it a new shine.

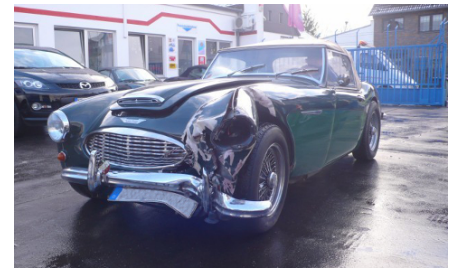
Beumer and his employees took stock of the damaged components. The list was long: The front headlights had been knocked out, the left-hand wing was warped and cracked, the head fairing was severely deformed, the bumper was twisted and the side member was bent. There looked to be a lot of work ahead.

The rear-end collision caused significant damage to the front left-hand side of the Austin-Healey 100-6 BN4.
